**DEPARTMENT OF TRANSPORTATION**

Contract #: 04-0120F4Cty: SF/ALA Rte: 80 PM: 13.2/13.9File #: 69.28**WELDING INSPECTION REPORT****Resident Engineer:** Pursell, Gary**Address:** 333 Burma Road**City:** Oakland, CA 94607**Report No:** WIR-001243**Date Inspected:** 10-Dec-2007**Project Name:** SAS Superstructure**OSM Arrival Time:** 630**Prime Contractor:** American Bridge/Fluor Enterprises, a JV**OSM Departure Time:** 1530**Contractor:** Zhenhua Port Machinery Company, Ltd (ZPMC), Changxing Island **Location:** Shanghai, China

**Bridge No:** 34-0006**Component:** 77m, 89m, 114m and #1 deck mock-ups**Summary of Items Observed:**

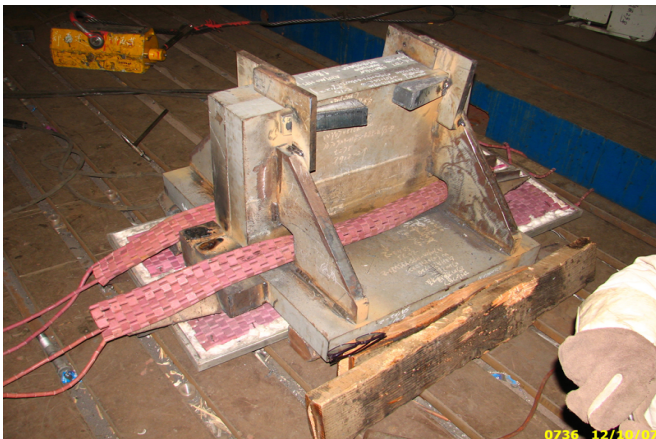
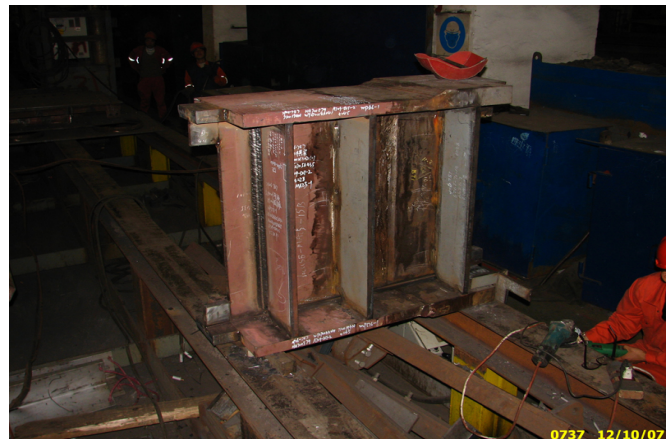
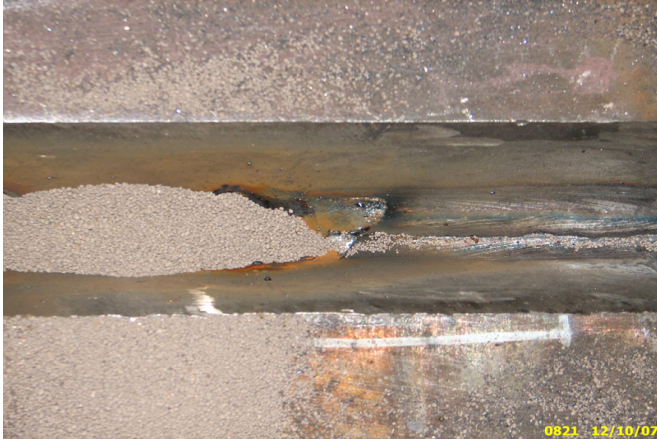
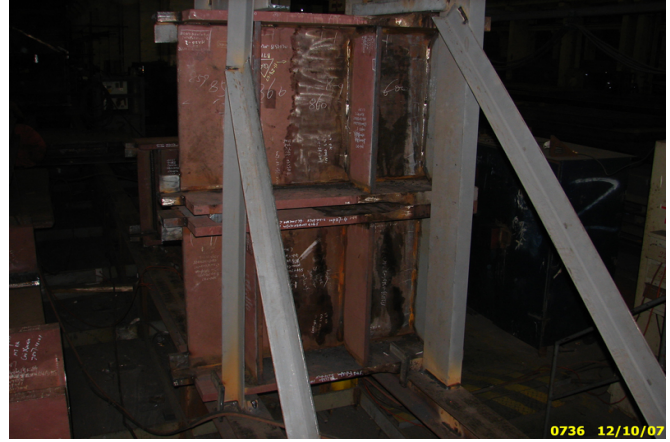
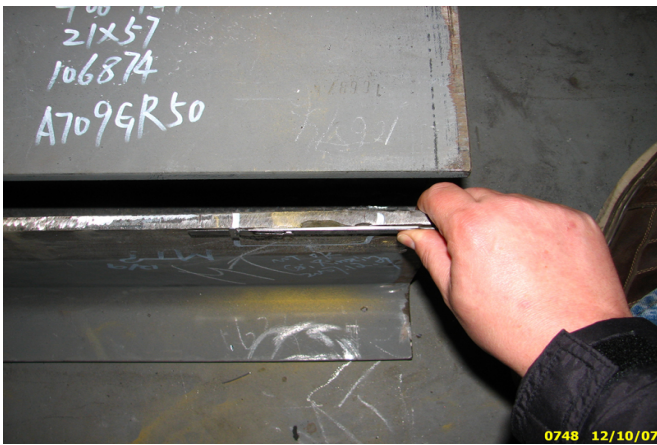
Included below are digital pictures that support the observations recorded within this report.

89m mock-up had Heat Straightening Report (HSR) active for MUSB-MA23 - Skin C center sections of the vertical longitudinal stiffeners, under HSR1-CT-165. ZPMC Certified Welding Inspector (CWI) Sha Zhi was actively monitoring temperatures for this operation. The Caltrans representative observed temperatures from 400 to 590 degrees centigrade yet a 593 degree Tempilstik brand temperature indicator did not melt. Observed actions appeared to be in accordance with the criteria set forth within the contractual documents.

On reporting date: 12/09/2007, Seismic Performance Critical Member (SPCM) plate 34A (BP002) was in the process of tack welding operations when the stiffener broke free and laid over on its side thus breaking a 27mm and 10mm piece of the stiffener edge off. ZPMC CWI, Lee Chen Woo, was notified of the incident. Per his previous request the area was ground down and then DMT inspected and accepted by ZPMC Inspector, Cai Xin Xin. Welding operation will resume later today for this component.
